Highway Route Review :- BOAT 57/74, Carmel Chapel, Burry Port to Penymynydd

Site Meeting / Safety Assessment (4th December 2014)

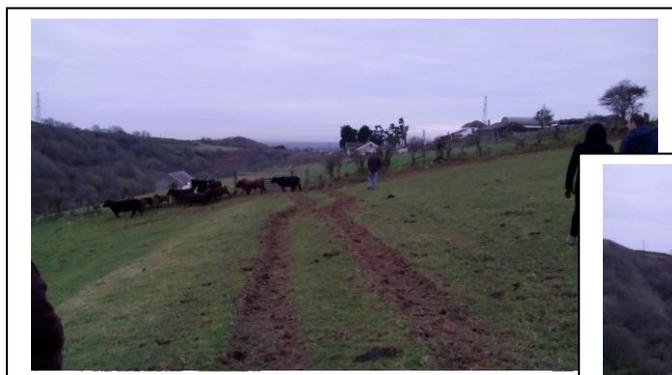
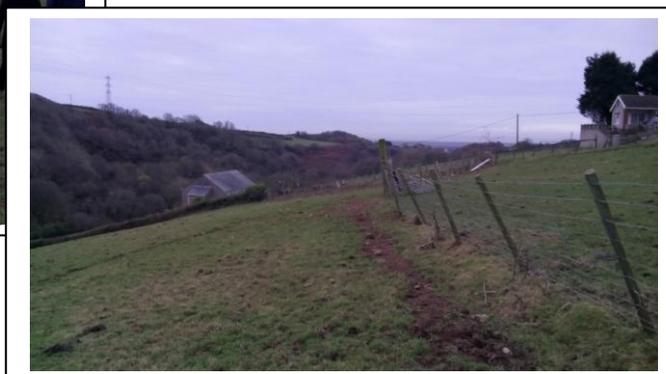
• **Chainage 964m – 1323m ~**

Open grass field with evidence of wheel tracks which follow the route of byway as indicated on plan. A stream needs to be traversed with approaches to both sides steep in gradient with increasing crossfall. Vertical alignment steepens as you travel through the stream with both approaches very muddy.

There are no hedge boundaries at this location only the presence of a wooden post and wire mesh stockproof fencing to the westerly side. The byway beyond Ch.1323m then traverses open fields with a very steep gradient to the easterly side.

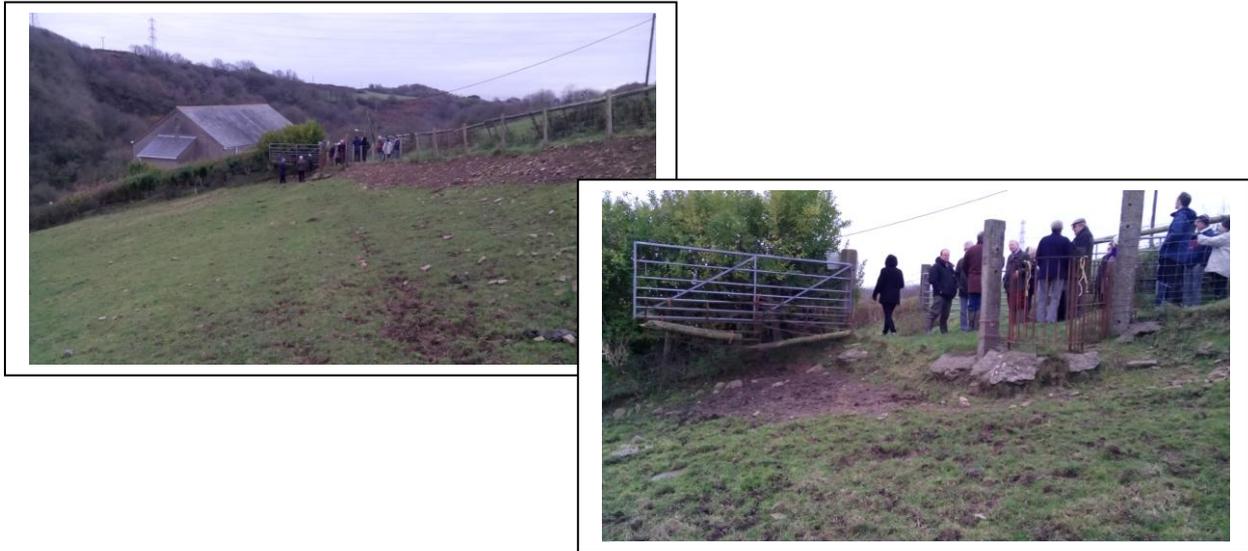
- **Chainage 1323m – 1528m ~**

From this chainage point the byway proceeds downhill at a very steep gradient and crossfall along the entire length of route to its end point adjacent the chapel. The route is located on an open grass field with no side boundary hedge protection and the field slopes steeply down to a river some 100 metres below. This section of the route was deemed a red zone or very high risk area for motorised vehicles due to the gradient and crossfall of the route.

The egress / access point of the byway is via a field gate directly onto the unclassified road and is approx 1 metre below carriageway level. Maintenance work would be needed at this point to allow safe access for highway users.

Implement a permanent Traffic Regulation Order restricting access by motorised vehicles. Access to be permitted for pedestrians, horse riders and motorcycles only. Meeting to be arranged with Transportation colleagues to discuss recommendations and process for implementation.
