S/36018

S/36018 — Previously Approved Scheme

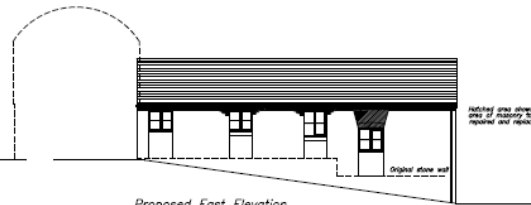
Proposed East Elevation

New extension to be constructed with the outer skin of natural stone to match main walls.

Extent of repair:
 Carefully take down existing fabric and loose stone/brickwork on East and West elevations. Remove all loose masonry along upper edges of existing on all elevations.
 Assess pattern of of mortar ties to existing on all elevations, refer to Structural Eng report.
 Rebuild masonry existing to match or existing up to original wall plate, retaining arched heads to openings. Provide new timber wall plate anchored to joists.
 Carry out local drilling of holes/levelling and abutting of vertical crack damage on North elevation with masonry to match existing.
 Take out and re-point all weathered joints with lime mortar. Install new cast iron gutter and construct using waterproofed bases of slotted castings and cover with roofing felt and natural slate tiles with matching ridge tiles.
 Finish large boards and sills to be treated softwood stained as required. Run water to goods to black plastic 'gape' profile.
